CHANNEL INCISION AT EAGLEHAWK CREEK, GIPPSLAND, VICTORIA, AUSTRALIA

By JULIET F. BIRD

Department of Geography, Melbourne State College, 757 Swanston Street, Carlton, Victoria 3053

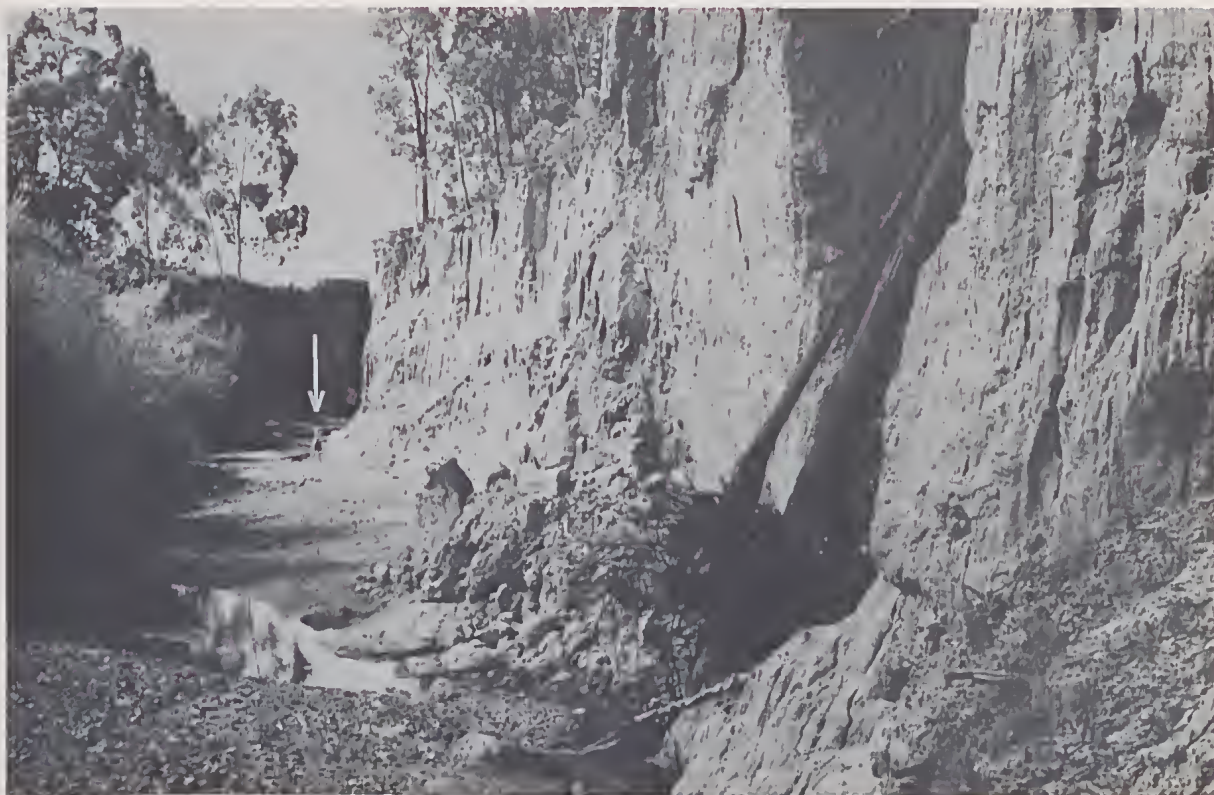
Fig. 2—Eaglehawk Creek 200 m downstream from Christensons, looking downstream. Figure arrowed for scale.

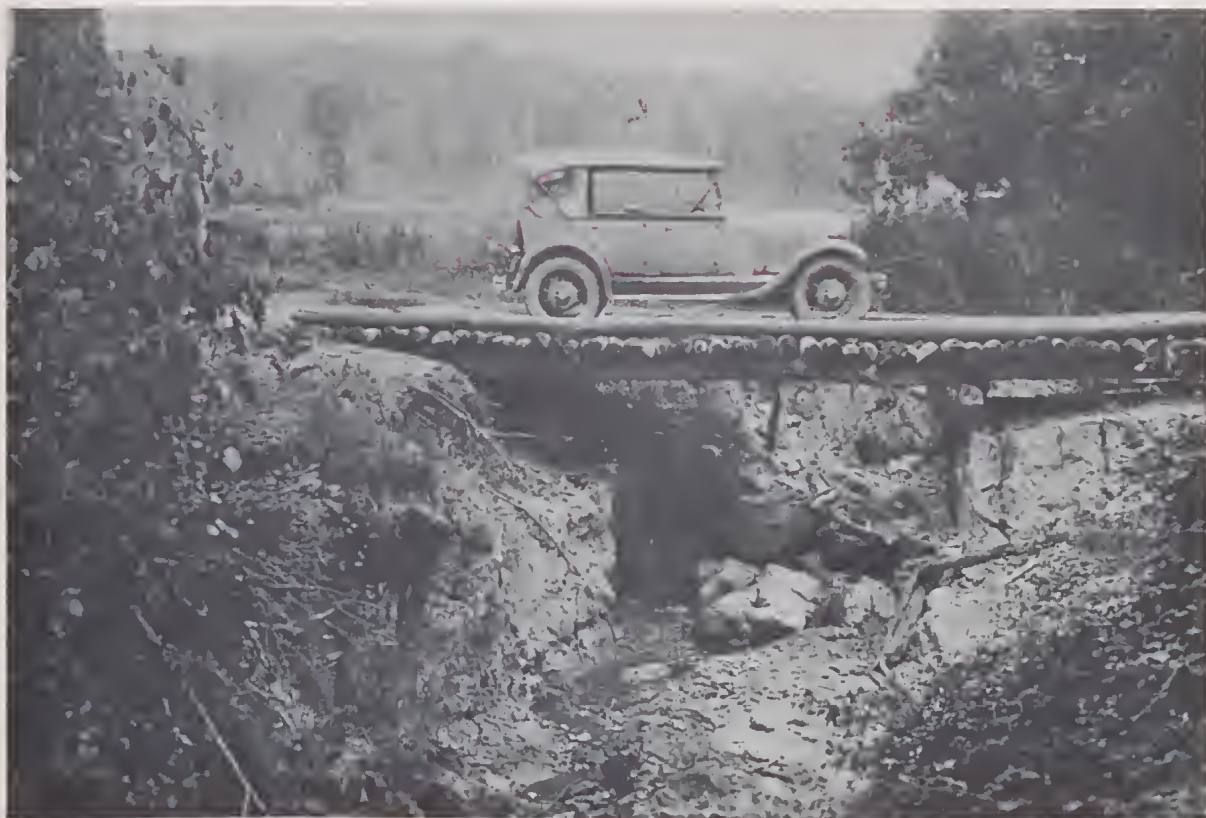
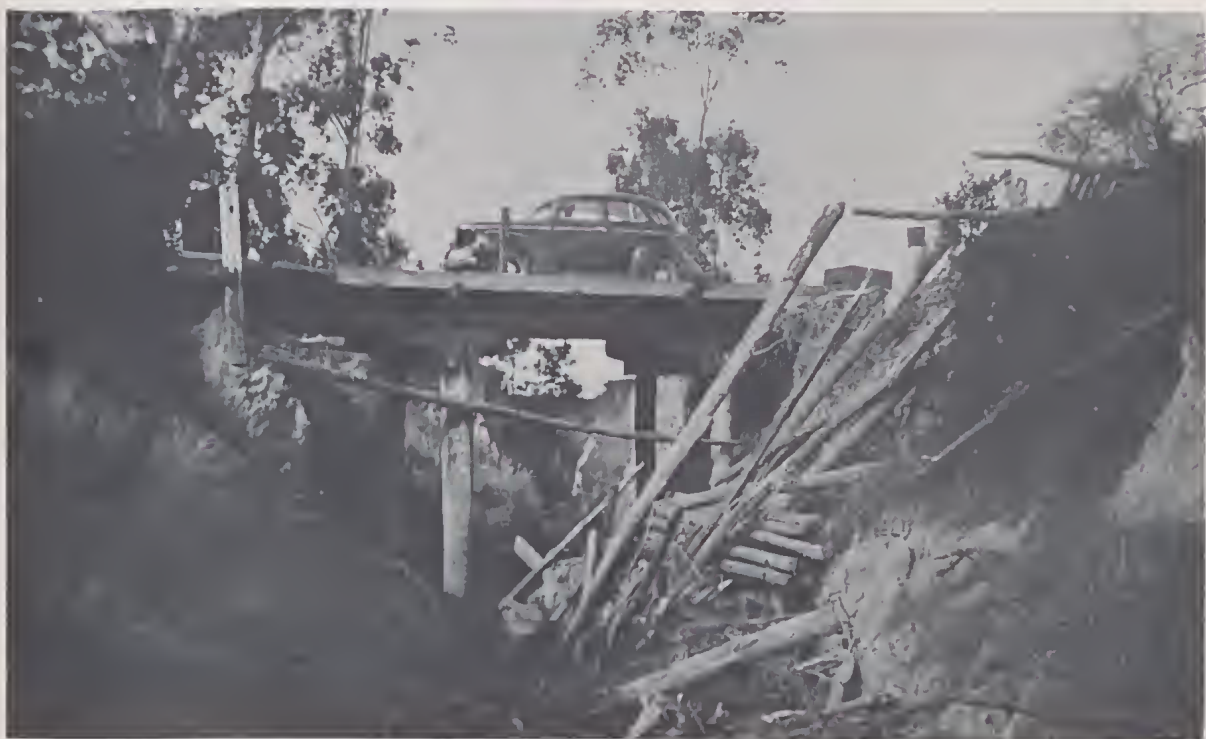
base of the spur dividing the two catchments. Incision spread rapidly back up the ditch into the old channel with the head of the erosion already 500 m above the confluence by 1935. By the early 1940s incision extended back to Berminghams, where it repeatedly cut the access track to the hills: attempts to maintain a bridge at this point (Fig. 3) were finally abandoned about 1952. (Date from Raymond Smith, son of the owner of a property upstream from this point, who depended on this bridge for access.) Figure 4 includes a cross section of the channel at the bridge site today. Like Eaglehawk, Stoney Creek has now cut down to bedrock in several places, and although further upstream extension of incision is likely, it will be a much slower process than in the lower course.

Fig. 3—A, Bridge across Stoney Creek at Berminghams, looking upstream. About 1936. (Source: R. Smith, Glengarry). B. Same site in August 1944. Remains of the old bridge in the foreground. (Source: State Rivers and Water Supply Commission photograph collection).

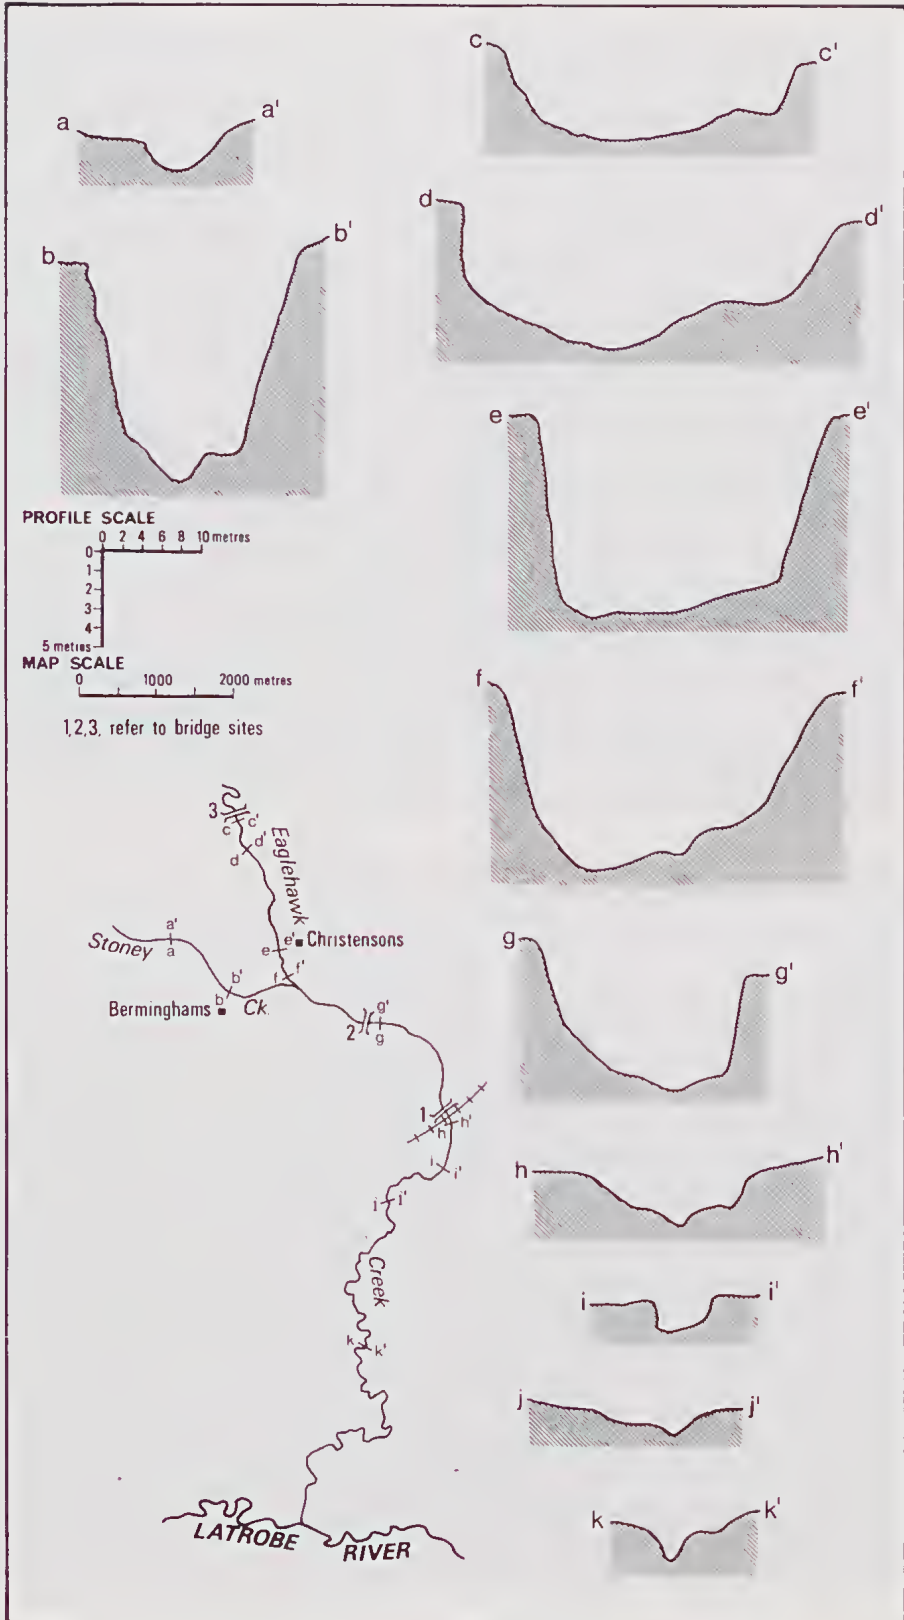
Fig. 4—Cross-sections of Eaglehawk and Stoney Creeks at the positions indicated.

in the sediment load. The change in sediment size may also be reflected in the the changing shape of the cross profile. Historical data suggest that deepening was dominant in the early years, so that sections attained a depth of 10 m or more by 1935; since that time the maximum depth has only increased to around 15 m, but the rate of sediment delivery downstream, together with the visible signs of bank undercutting, show that widening, particularly on bends, is still active. Schumm (1977) has demonstrated that channel width-depth ratios are related to sediment size, and the transition from dominant down-cutting to dominant widening may be associated with the increasing proportion of bed load in transit. This may also explain the lower width-depth ratios noted in Stoney Creek, which is deeper and narrower (Fig. 4) and carries finer debris.

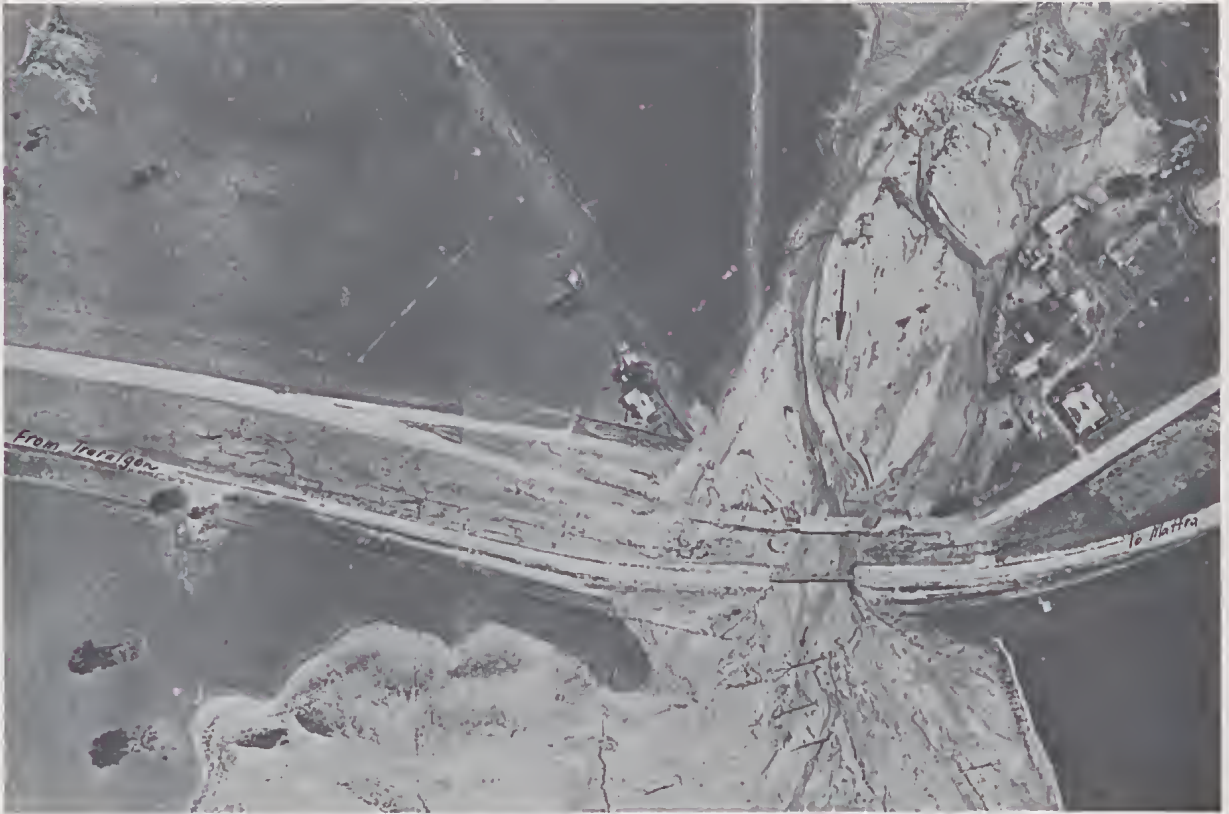
In the 1930s attempts to deal with problems resulting from the erosion of Eaglehawk and Stoney Creeks were confined to periodic excavation of the waterway beneath the main-road and rail bridges, but it became increasingly evident that the problem of infilling could only be solved by the insertion of sediment traps and erosion controls upstream. At first attempts to do this were on a very small scale consisting mainly of brushwood weirs across the channel floor. None of the structures lasted more than a few months before they were washed out by floods, and though the Rosedale Shire Council had consultations with the Soil Conservation Board and the State Rivers and Water Supply Commission in 1942 over a proposal for construction of a major dam across Eaglehawk Creek, no further action was taken for some years. In 1949 the Country Roads Board replaced the old main-road bridge with a new one having a 2 m clearance above the river bed; the following year the Railways, too, replaced their bridge with a new, higher level structure on what was considered an improved alignment. Floods in 1952 washed out the approach to the new road bridge (Fig. 5) and went over the raised rail bridge, but problems at the bridge sites have subsequently diminished.

Fig. 5—Aerial photograph of the main road and rail bridges taken just after the 1952 floods, showing sand splays. (Source: Victorian Railways).

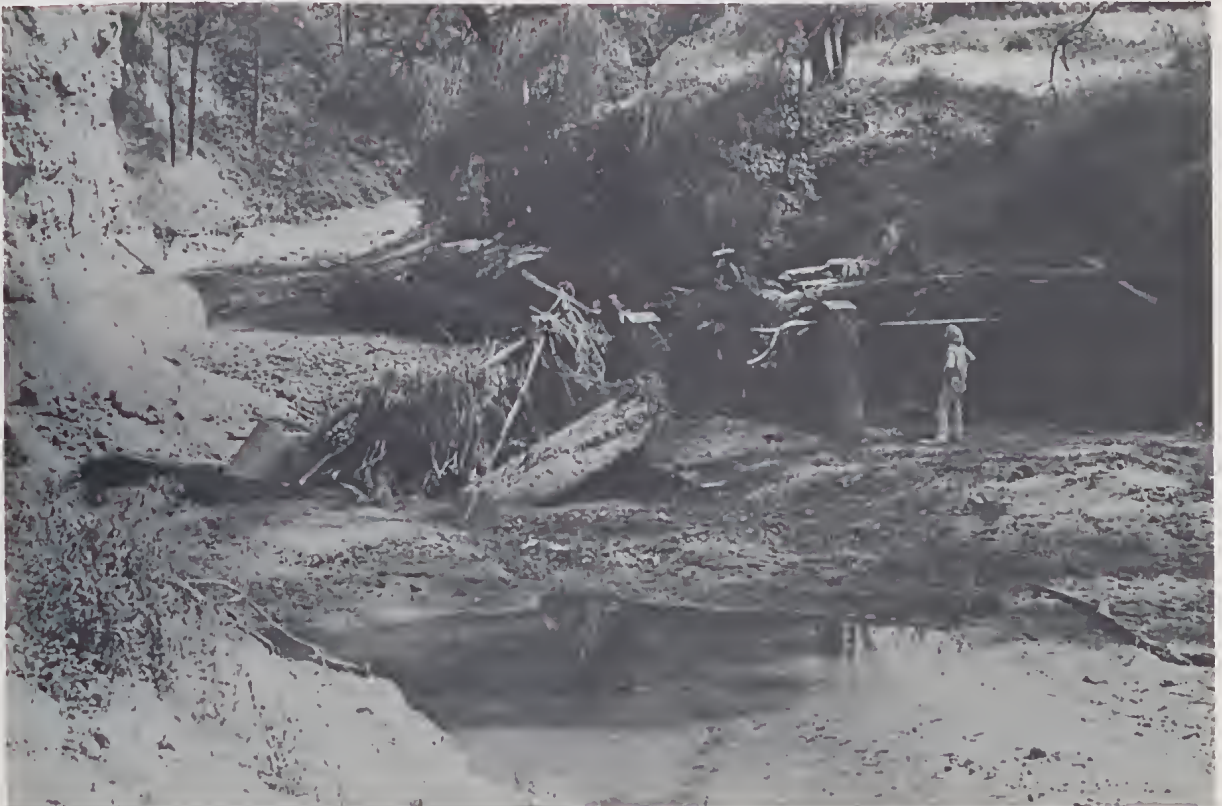
through insertion of concrete drop structures was made using Drought Relief Funds to provide local employment, but a flash flood of January 1971 caused severe damage to the new weirs (Fig. 6), and today there are none on Stoney Creek, and only two intact on the upper part of Eaglehawk. A concrete block structure protects the Glengarry North Road Bridge, while a low concrete wall across the creek bed just above the main bridge traps some of the sediment arriving from upstream. Current erosion "control" is limited to annual bulldozing by the Latrobe River Improvement Trust designed to remove obstacles from the channel floor, and redirect the current away from the eastern bank where undermining results in the loss of valuable farmland. The enlarged waterway beneath the bridges and periodic straightening of the channel through the sediment splays has resulted in progressive downstream migration of the toe of the "delta" or sand splay area. If the process continues coarse sediment may eventually be delivered onto the flood plain of the Latrobe River or even, like the silt, into the Latrobe River itself.

Fig. 6—Wood and concrete drop structure across Eaglehawk Creek outflanked by bank erosion. Looking upstream.

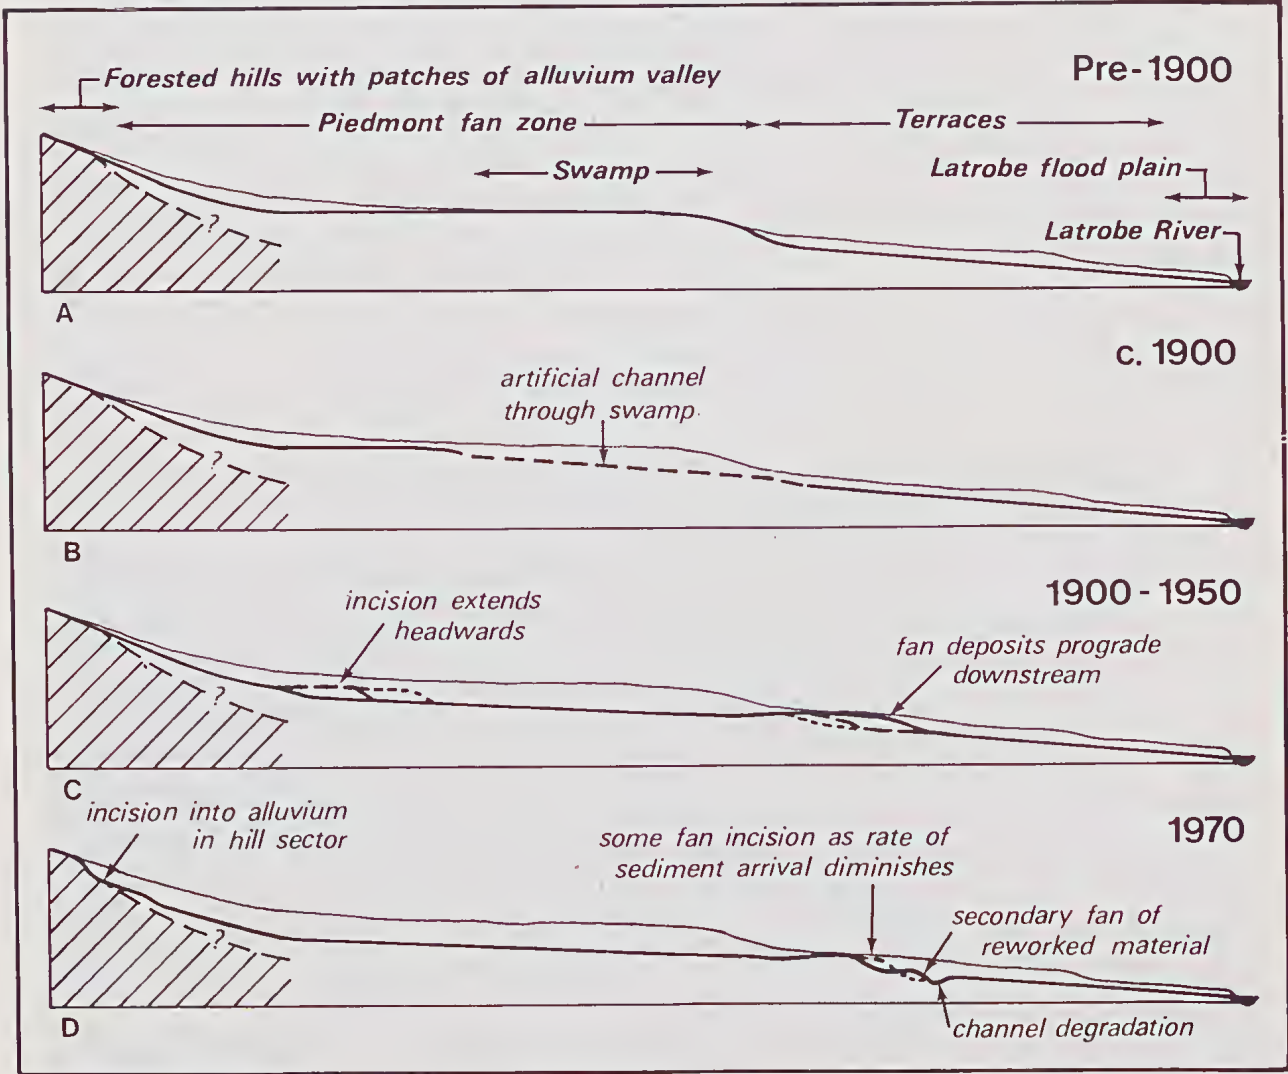
The excavation of a continuous channel through the swamp which once formed a local base level for the upper part of Eaglehawk Creek has also caused erosion. Water now flows to a new base level at the Latrobe River. Figure 7 shows evolution of the new long profile in diagrammatic form. This erosion began in the upper part of the natural channel across the terrace as the relatively steep gradients of the head of a water course became adjusted to the lower gradients of a middle reach. The deepening was then transmitted upstream through headward migration of knickpoints. The channel is deepest where it passes through higher parts of the undulating surface of the fan. This adjustment of long profile is complicated by the redeposition of eroded material as regional gradients diminish from fan to terrace. The redeposition creates a new and steeper gradient at the lower end of the sand splays. As deepening upstream diminishes and the rate of arrival of new sediment declines, the channel starts to erode back through this oversteepened sector creating a new, lower, sand splay as this material in turn is redeposited downstream. Erosion of the channel back up into the fan is comparable to the sequence described by Schumm and Hadley in Wyoming and New Mexico (1957): trenching appears to be initiated at the toe of fan once surface gradients exceed a threshold value, which in the case of Eaglehawk Creek lies at about 0.012. Below the lowest splay the water emerges minus its coarser sediment load, and possessed of superfluous energy. Several authors,

Fig. 7—A, Under natural conditions Eaglehawk Creek had two sectors with a clearly defined channel separated by a swamp which served as base level for the upper channel. B, About 1895 a drain was cut through the swamp, linking the upper and lower channels. C, The steepened reach of the man-made channel through the swamp began to incise back into the upper part of the fan zone. At the same time redeposition of eroded materials built up a new prograding fan across the terrace below the swamp. D, As the incised channel extended back into the hills the rate of erosion slowed, and supply of sediment to the downstream depositional area diminished. The channel at the lower end of the post-settlement fan then began to cut back, creating a secondary sediment splay at the downstream end. Water minus its sand and gravel load emerging from the toe of this secondary splay caused degradation of the channel immediately downstream.
